**Flood Control Project Maintenance
Levee Inspections**
LMA District Cover Sheet
Spring 2014 Levee Inspection Results

Reclamation District No. 0784 Plumas Lake

Levee Inspection Report By Mile - Spring 2014

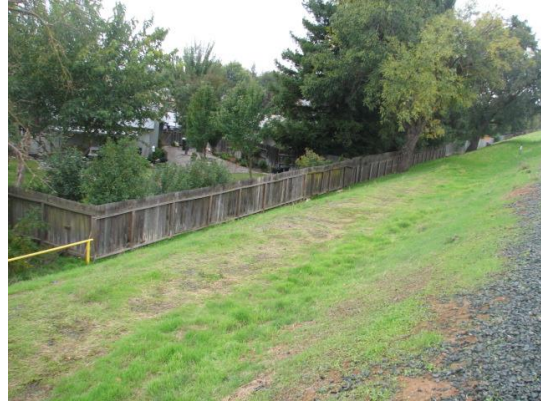
Photo 1 of 1 : mhoffman_s_20140401_345.jpg

LM Start	0.52	Rating **	U	Issue No.	12
LM End	1.00	Issue Type +	En	Location *	LS
Category	Earthen Levee			GPS Latitude/Longitude	
				Start	End
Item	Encroachments			39.131558 °	39.129475 °
				-121.560668 °	-121.569209 °
DWR ID	DWR_RD0784_01_f _ 2012_12				
Action/Comments					
Urban

Levee mile 0.53-1.00, this photo shows the fences and other obstruction near the toe of the levee on the landside.

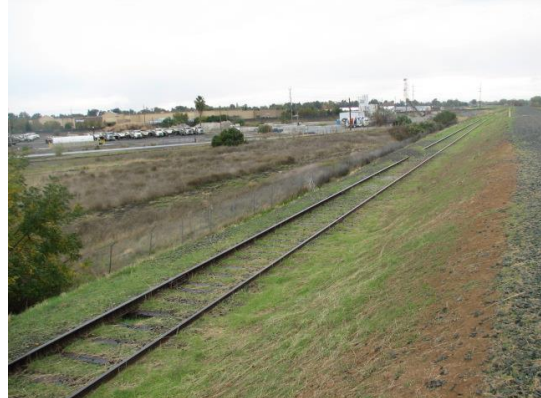
Photo 1 of 1 : mhoffman_s_20140401_346.jpg

LM Start	1.00	Rating **	U	Issue No.	13
LM End	1.12	Issue Type +	En	Location *	LS
Category	Earthen Levee			GPS Latitude/Longitude	
				Start	End
Item	Encroachments			39.129475 °	39.129615 °
				-121.569210 °	-121.571371 °
DWR ID	DWR_RD0784_01_f _ 2012_13				
Action/Comments					
Fence

Levee mile 1.00-1.12, this photo shows a fence near the levee toe on the landside.

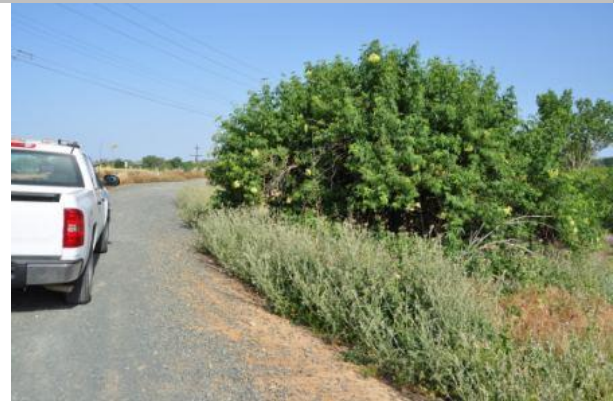
Photo 1 of 1 : mhoffman_s_20140401_344.jpg

LM Start	1.28	Rating **	M	Issue No.	2
LM End	1.28	Issue Type +	Ma	Location *	WS
Category	Earthen Levee			GPS Latitude/Longitude	
				Start	End
Item	Vegetation			39.129783 °	39.129783 °
				-121.574384 °	-121.574384 °
DWR ID	DWR_RD0784_01_s _ 2012_2				
Action/Comments					
Elderberries are blocking visibility and flood fight capability.

W/S slope vegetation, Elderberry.

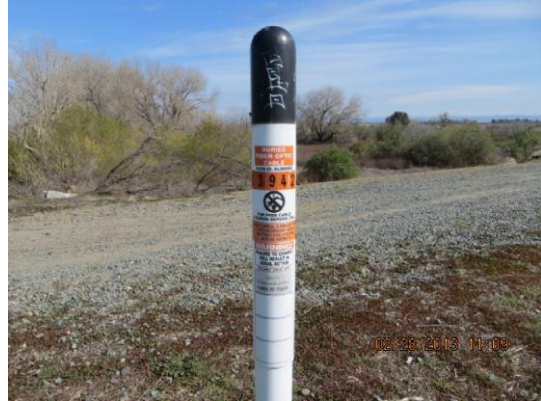
Photo 1 of 1 : UCIP_5997.jpg

LM Start	1.32	Rating **	M	Issue No.	1
LM End	1.32	Issue Type +	En	Location *	WS
Category	Supplemental			GPS Latitude/Longitude	
				Start	End
Item	DWR UCIP Field Study			39.129826 °	39.129826 °
				-121.574940 °	-121.574940 °
DWR ID	DWR_RD0784_01_s_2014_1				
Action/Comments					
Inspector Comments: FS_ID:29363					
EP_NO: N/A					
Repair Type:					
Crossing Status:					
UCIP Comments: No permit identified for this crossing. Need to determine if owner has permit.					
FIELD_STRUCT_DESC: Fiber Optic Communication lines cross levee.					
Diameter unknown.					
FS Date: 2/13/2014 9:24:00 AM

Marker on east side of Rail/WS of Levee.

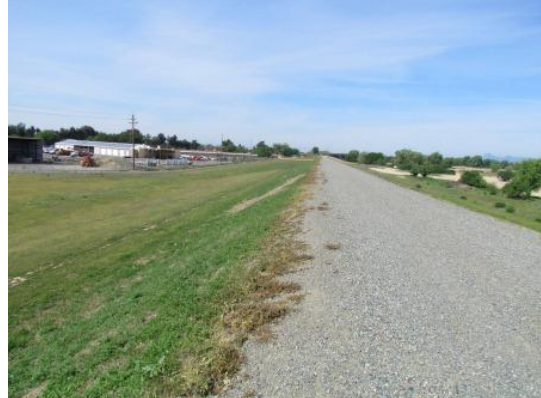
Photo 1 of 1 : mhoffman_s_20140410_421.jpg

LM Start	1.47	Rating **	A	Issue No.	3
LM End	1.47	Issue Type +	Ma	Location *	LS
Category	Earthen Levee			GPS Latitude/Longitude	
				Start	End
Item	Vegetation			39.129904 °	39.129904 °
				-121.577878 °	-121.577878 °
DWR ID	DWR_RD0784_01_s_2014_3				
Action/Comments					
Control annual grass and weeds on the levee slopes and easements.

This photo was taken from the crown facing west looking down the landward levee slope at acceptable vegetation maintenance. Spring 2014.

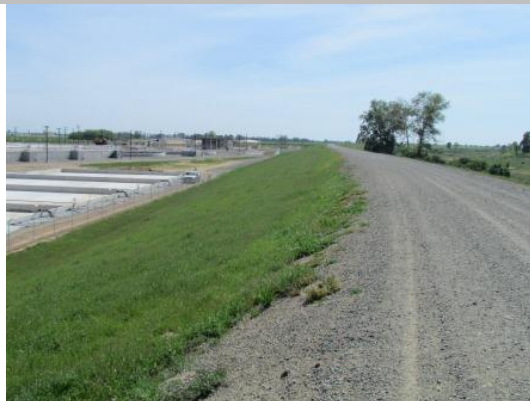
Photo 1 of 1 : mhoffman_s_20140410_423.jpg

This photo was taken from the crown facing south looking down the landward levee slope at acceptable vegetation maintenance. Spring 2014.

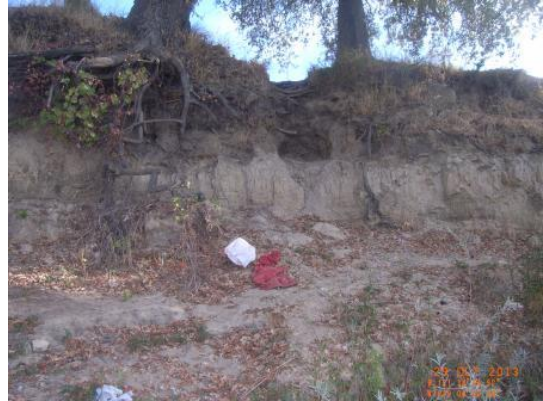
Photo 1 of 1 : USACE2013A_FHR_17-8_L_11.jpg

Inspector Comments: 2003 - Bank is near vertical. Identified as a Potentially Critical site. 2004 - Eddy flow off downstream end of Modesto formation eroding the fluvial sediments. 2005 - Some new slumping. Actively eroding but berm width is greater than 50 ft. 2006 - Downgraded to regular erosion site. Still actively eroding. Large old rotational failures in high bank on the downstream end. 2008 - Removed from inventory due to wide berm width does not meet criteria for an erosion site. 2010 - Added back to the inventory after 10 ft of bank erosion in the winter 2009 storm. Steep vertical face. 2011 - Bank has retreated an additional 2.5 ft from last year. New tree popouts and erosion throughout the site. 2012 - Site continues to worsen with new tree popouts and many sections of new erosion. 2013: No observed changes. [2013 Site ID: FHR_17-8_L]

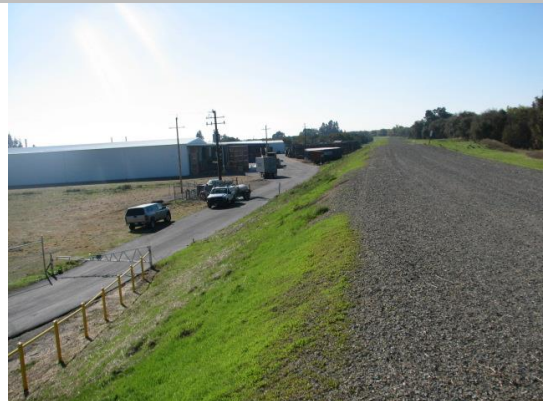
Photo 1 of 1 : mhoffman_s_20140401_342.jpg

LM Start	9.21	Rating **	U	Issue No.	6
LM End	9.29	Issue Type +	En	Location *	LS
Category	Earthen Levee			GPS Latitude/Longitude	
				Start	End
Item	Encroachments			39.006523 °	39.005235 °
				-121.577843 °	-121.578286 °
DWR ID	DWR_RD0784_02 f _ 2012_6

Levee mile 9.21, new paving near the levee toe, no permit found for this work.

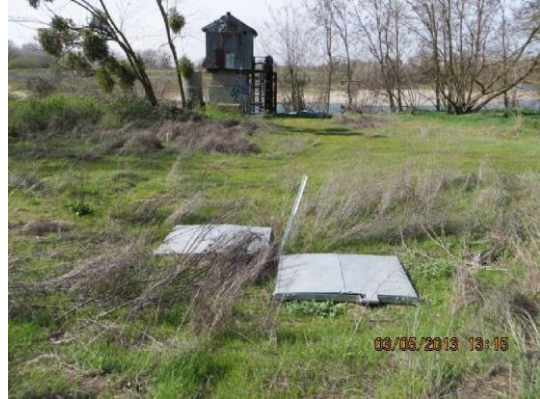
Photo 1 of 1 : UCIP_5937.jpg

LM Start	9.25	Rating **	M	Issue No.	3
LM End	9.25	Issue Type +	En	Location *	LS
Category	Supplemental			GPS Latitude/Longitude	
				Start	End
Item	DWR UCIP Field Study			39.005970 °	39.005970 °
				-121.578008 °	-121.578008 °
DWR ID	DWR_RD0784_02B_s _ 2014_3				
Action/Comments					
Inspector Comments: FS_ID:29288					
EP_NO: 18227					
Repair Type:					
Crossing Status:					
UCIP Comments: Gate on enclosure at LS toe is not locked. Vaults on WS toe are open and need to be secured.					
FIELD_STRUCT_DESC: 1 of 3: 30-inch HDPE irrigation pipe through the levee 3-feet below the crown. Siphon breaker and air relief valve in vault on waterside shoulder. Pumps in pump house on the bank. Gate valves in concrete distribution box. Chain link enclosure at the landside toe. Discharges into concrete box on the landward side. (Permit No. 18227, 2007)					
FS Date: 2/13/2014 9:24:24 AM

Pumphouse off WS toe at waters edge. Vaults with access to pipes in foreground.

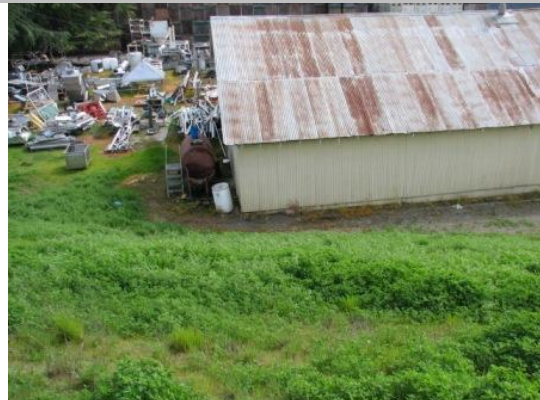
Photo 1 of 1 : mhoffman_s_20140401_336.jpg

LM Start	9.40	Rating **	U	Issue No.	1
LM End	9.40	Issue Type +	En	Location *	LS
Category	Earthen Levee			GPS Latitude/Longitude	
				Start	End
Item	Encroachments			39.003905 °	39.003905 °
				-121.578774 °	-121.578774 °
DWR ID	DWR_RD0784_02_s _ 2012_1				
Action/Comments					
Building

Levee mile 9.40, looking at a building that is encroaching on the levee toe.

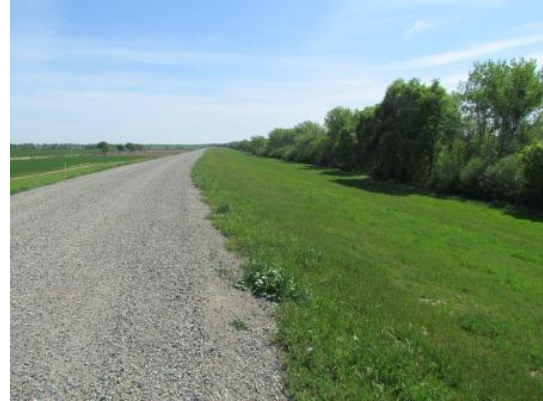
Photo 1 of 1 : mhoffman_s_20140410_425.jpg

This photo was taken from the crown facing south looking down the waterward levee slope at acceptable vegetation maintenance. Spring 2014.

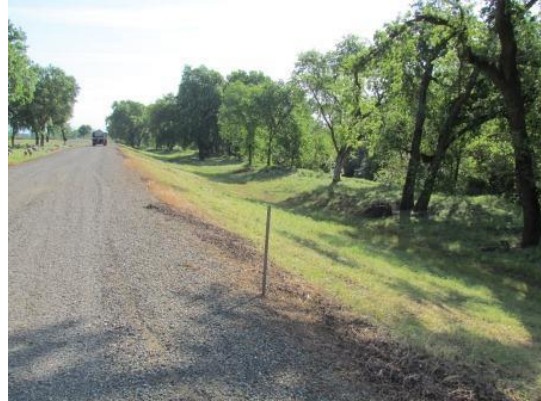
Photo 1 of 1 : mhoffman_s_20140410_427.jpg

This photo was taken from the crown facing east looking down the waterward levee slope at acceptable vegetation maintenance. Spring 2014.

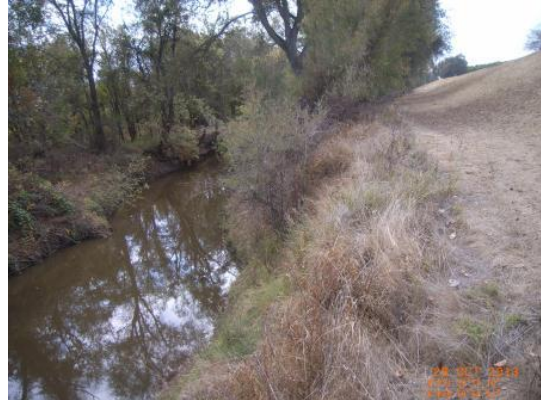
Photo 1 of 1 : USACE2013A_BER_4-9_R_4.jpg

LM Start	4.31	Rating **	M	Issue No.	3
LM End	4.32	Issue Type +	Ma	Location *	WS
Category	Supplemental			GPS Latitude/Longitude	
				Start	End
Item	USACE Erosion Survey			38.981400 °	38.981271 °
				-121.515848 °	-121.515999 °
DWR ID					
Action/Comments					
Inspector Comments: 2009 - Small site which could be repaired with maintenance. Erosion into the levee toe, rock has started to fail. 2013: No observed changes. [2013 Site ID: BER_4-9_R]

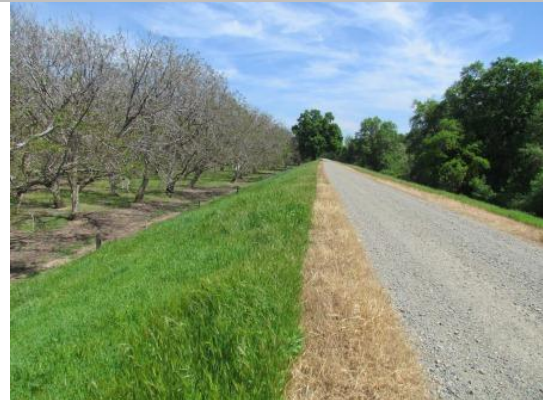
Photo 1 of 1 : mhoffman_s_20140414_430.jpg

This photo was taken from the crown facing east looking down the landward levee slope at vegetation requiring maintenance. Spring 2014.

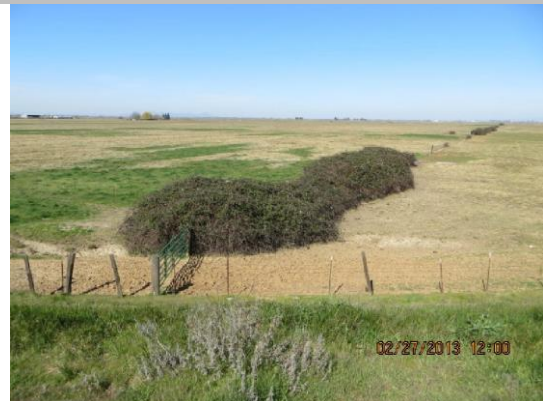
Photo 1 of 1 : UCIP_5925.jpg

LM Start	4.69	Rating **	M	Issue No.	2
LM End	4.69	Issue Type +	En	Location *	LS
Category	Supplemental			GPS Latitude/Longitude	
				Start	End
Item	DWR UCIP Field Study			38.985247 °	38.985247 °
				-121.511075 °	-121.511075 °
DWR ID	DWR_RD0784_03B_s_2014_2				
Action/Comments					
Inspector Comments: FS_ID:29284					
EP_NO: N/A					
Repair Type:					
Crossing Status:					
UCIP Comments: Flap gate blocked by vegetation on WS toe. Unable to locate inlet.					
FIELD_STRUCT_DESC: 18-inch CM drain pipe through the levee 20-feet below the crown. Gate valve on waterward side. Originally included in O+M Manual (1955).					
FS Date: 2/13/2014 9:16:07 AM

Unable to locate inlet due to blackberry overgrowth on LS toe.

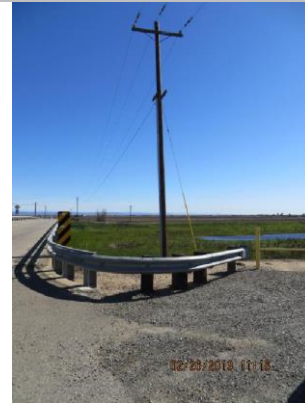
Photo 1 of 1 : UCIP_5943.jpg

LM Start	3.60	Rating **	M	Issue No.	1
LM End	3.60	Issue Type +	En	Location *	WS
Category	Supplemental			GPS Latitude/Longitude	
				Start	End
Item	DWR UCIP Field Study			39.026347 °	39.026347 °
				-121.542343 °	-121.542343 °
DWR ID	DWR_RD0784_04_s_2014_1				
Action/Comments					
Inspector Comments: FS_ID:29289					
EP_NO: N/A					
Repair Type:					
Crossing Status:					
UCIP Comments: No permit identified for crossing.					
FIELD_STRUCT_DESC: Communication line through the levee at unknown depth on downstream side of bridge.					
FS Date: 2/13/2014 9:24:53 AM

Communication line at base of JP on WS slope.

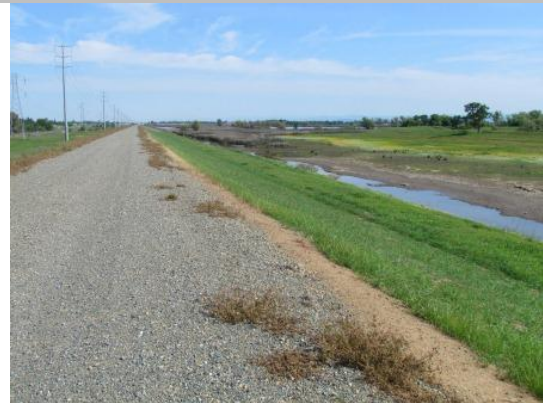
Photo 1 of 1 : mhoffman_s_20140410_428.jpg

LM Start	4.63	Rating **	A	Issue No.	3
LM End	4.63	Issue Type +	Ma	Location *	WS
Category	Earthen Levee			GPS Latitude/Longitude	
				Start	End
Item	Vegetation			39.041131 °	39.041131 °
				-121.542399 °	-121.542399 °
DWR ID	DWR_RD0784_04_s_2014_3				
Action/Comments					
Control annual grass and weeds on the levee slopes and easements.

This photo was taken from the crown facing north looking down the waterward levee slope at acceptable vegetation maintenance. Spring 2014.

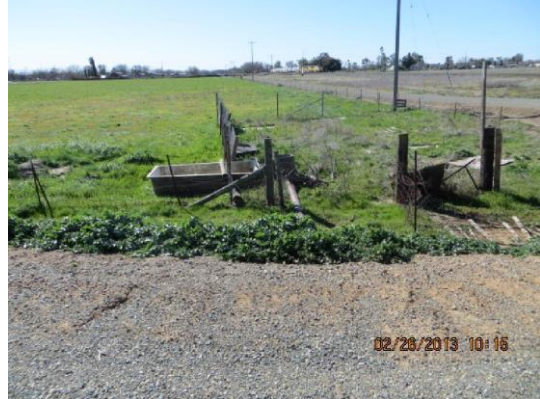
Photo 1 of 1 : UCIP_5932.jpg

UCIP Comments: Large animal burrough along pipe alignment on WS has undermined pipe for an unknown length. Pipe is corroded through on WS. Pipe should be properly abandoned.

Concrete riser and pipe on LS toe.

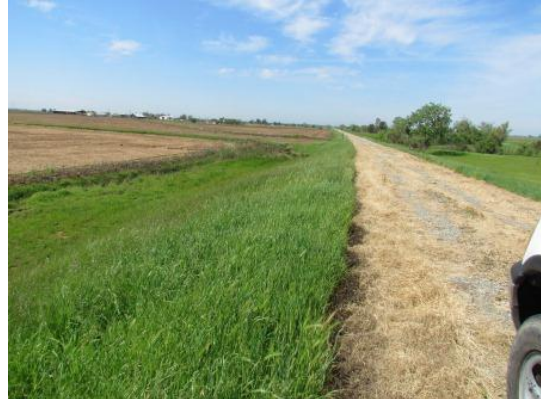
Photo 1 of 1 : mhoffman_s_20140410_429.jpg

This photo was taken from the crown facing west looking down the landward levee slope at vegetation requiring maintenance. Spring 2014.

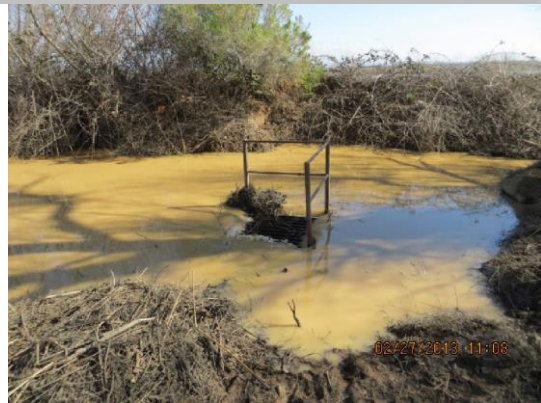
Photo 1 of 1 : UCIP_5945.jpg

LM Start	0.83	Rating **	M	Issue No.	1
LM End	0.83	Issue Type +	En	Location *	LS
Category	Supplemental			GPS Latitude/Longitude	
				Start	End
Item	DWR UCIP Field Study			38.986432 °	38.986432 °
				-121.534983 °	-121.534983 °
DWR ID	DWR_RD0784_05_s _ 2014_1				
Action/Comments					
Inspector Comments: FS_ID:29290					
EP_NO: N/A					
Repair Type:					
Crossing Status:					
UCIP Comments: No handle or access to slide gate on LS toe.					
FIELD_STRUCT_DESC: 30-inch CM pipe through the levee 23.7 feet below the crown. Flap gate on the waterward end. Slide gate in concrete drop inlet on the landward side. Originally included in O+M manual (1955).					
FS Date: 2/13/2014 9:25:25 AM

Concrete drop-inlet at LS toe.

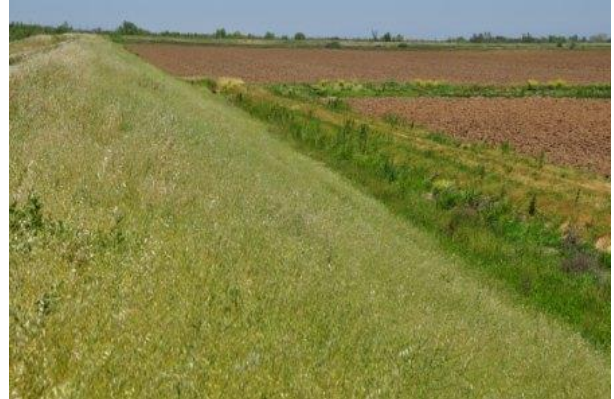
Photo 1 of 1 : mhoffman_s_20140401_322.jpg

Ditch at L/S toe.

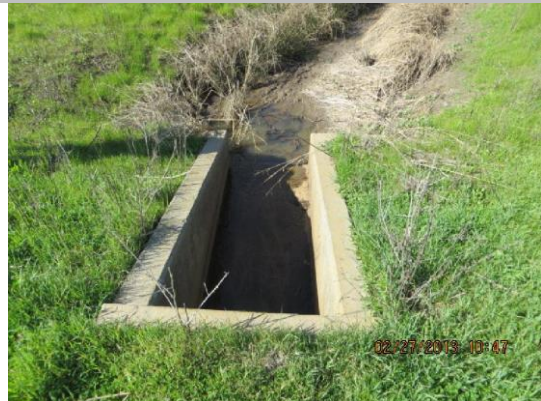
Photo 1 of 1 : UCIP_5946.jpg

LM Start	1.85	Rating **	M	Issue No.	2
LM End	1.85	Issue Type +	En	Location *	LS
Category	Supplemental			GPS Latitude/Longitude	
				Start	End
Item	DWR UCIP Field Study			39.000975 °	39.000975 °
				-121.537779 °	-121.537779 °
DWR ID	DWR_RD0784_05_s_2014_2				
Action/Comments					
Inspector Comments: FS_ID:29291					
EP_NO: N/A					
Repair Type:					
Crossing Status:					
UCIP Comments: Inlet burried. Good candidate for video inspection as pipe is corroded.					
FIELD_STRUCT_DESC: 18-inch CM drain pipe through the levee, 14.5 feet below the crown. Flap gate on the waterward end. Concrete "U" headwall on the waterward side. Originally included in O+M manual (1955).					
FS Date: 2/13/2014 9:25:46 AM

Concrete U-shaped outlet and flap-gate on WS toe.

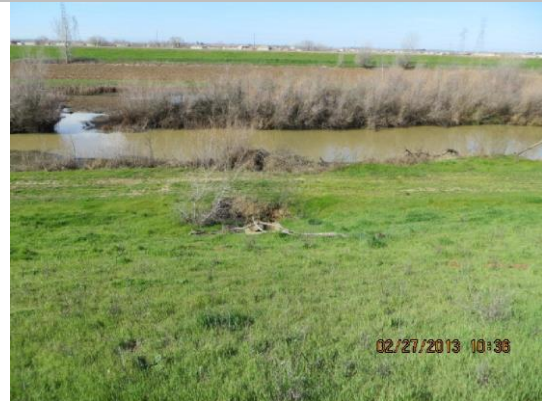
Photo 1 of 1 : UCIP_5951.jpg

LM Start	2.04	Rating **	M	Issue No.	4
LM End	2.04	Issue Type +	En	Location *	LS
Category	Supplemental			GPS Latitude/Longitude	
				Start	End
Item	DWR UCIP Field Study			39.003643 °	39.003643 °
				-121.538292 °	-121.538292 °
DWR ID	DWR_RD0784_05_s_2014_4				
Action/Comments					
Inspector Comments: FS_ID:29292					
EP_NO: N/A					
Repair Type:					
Crossing Status:					
UCIP Comments: Erosion at outlet may or may not be an issue.					
FIELD_STRUCT_DESC: 18-inch CM drain pipe through the levee, 14.5 feet below the crown. Flap gate on the waterward end. Concrete "U" headwall on the waterward side. PVC weir on inlet. Originally included in O+M manual (1955).					
FS Date: 2/13/2014 9:26:10 AM

Concrete U-shaped outlet on WS toe.

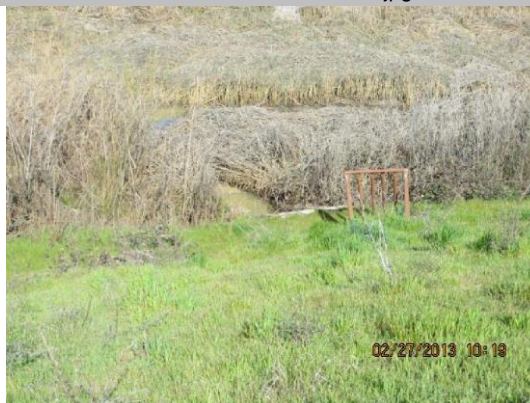
Photo 1 of 1 : UCIP_5955.jpg

LM Start	2.47	Rating **	M	Issue No.	8
LM End	2.47	Issue Type +	En	Location *	LS
Category	Supplemental			GPS Latitude/Longitude	
				Start	End
Item	DWR UCIP Field Study			39.008994 °	39.008994 °
				-121.535679 °	-121.535679 °
DWR ID	DWR_RD0784_05_s _ 2014_8				
Action/Comments					
Inspector Comments: FS_ID:29293					
EP_NO: N/A					
Repair Type:					
Crossing Status:					
UCIP Comments: Heavy erosion around inlet headwall due to beaver activity.					
FIELD_STRUCT_DESC: 18-inch CM drain pipe through the levee, 15.5 feet below the crown. Flap gate on the waterward end. Concrete "U" headwall on the waterward side. Originally included in O+M manual (1955).					
FS Date: 2/13/2014 9:26:39 AM

Outlet on WS.

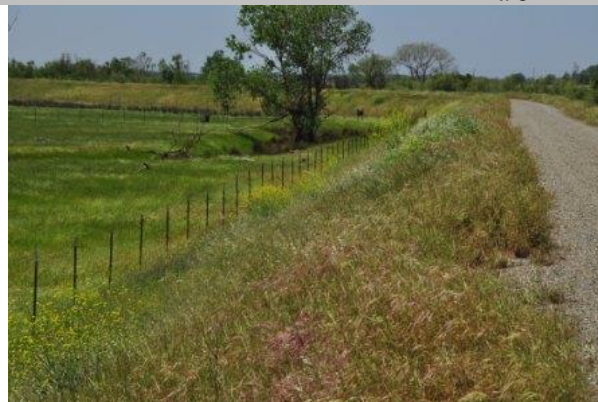
Photo 1 of 1 : mhoffman_s_20140401_321.jpg

LM Start	2.51	Rating **	U	Issue No.	5
LM End	3.36	Issue Type +	En	Location *	LS
Category	Earthen Levee			GPS Latitude/Longitude	
				Start	End
Item	Encroachments			39.009439 °	39.017779 °
				-121.535210 °	-121.524150 °
DWR ID	DWR_RD0784_05_s _ 2013_5				
Action/Comments					
Fence

Fence at L/S levee toe.

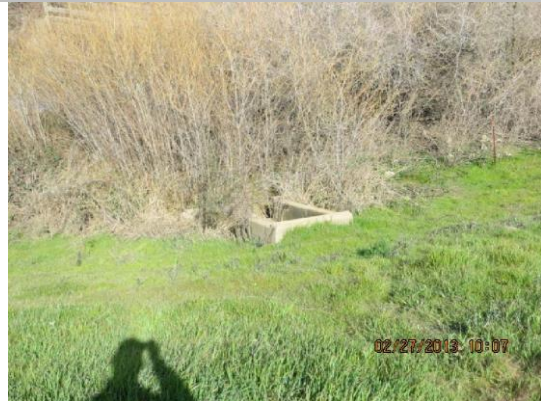
Photo 1 of 1 : UCIP_5960.jpg

LM Start	3.06	Rating **	M	Issue No.	11
LM End	3.06	Issue Type +	En	Location *	WS
Category	Supplemental			GPS Latitude/Longitude	
				Start	End
Item	DWR UCIP Field Study			39.015549 °	39.015549 °
				-121.528590 °	-121.528590 °
DWR ID	DWR_RD0784_05_s_2014_11				
Action/Comments					
Inspector Comments: FS_ID:29294					
EP_NO: N/A					
Repair Type:					
Crossing Status:					
UCIP Comments: Pipe has been sliplined with PVC, but the liner appears to be eroding at outlet and may be disjointed internal to the levee. See pic. Good candidate for video inspection.					
FIELD_STRUCT_DESC: 12-inch CM drain pipe through the levee, 12.0 feet below the crown. Flap gate and concrete "U" headwall on the waterward side. PVC weir on inlet at LS toe. Originally included in O+M manual (1955).					
FS Date: 2/13/2014 9:27:13 AM

Concrete U-shaped headwall on WS toe.

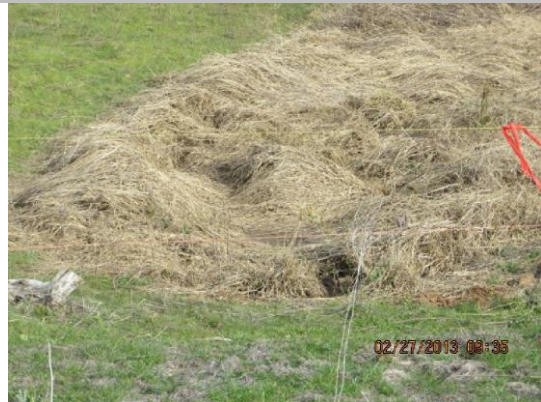
Photo 1 of 1 : UCIP_5963.jpg

LM Start	3.96	Rating **	M	Issue No.	12
LM End	3.96	Issue Type +	En	Location *	WS
Category	Supplemental			GPS Latitude/Longitude	
				Start	End
Item	DWR UCIP Field Study			39.019787 °	39.019787 °
				-121.513386 °	-121.513386 °
DWR ID	DWR_RD0784_05_s_2014_12				
Action/Comments					
Inspector Comments: FS_ID:29295					
EP_NO: N/A					
Repair Type:					
Crossing Status:					
UCIP Comments: Pipe burried on LS toe and flap gate is blocked by soil on WS toe.					
FIELD_STRUCT_DESC: 18-inch CM pipe through the levee, 10.0 feet below the crown. Flap gate on the waterward end. Originally included in O+M manual (1955).					
FS Date: 2/13/2014 9:27:34 AM

Outlet on WS toe .

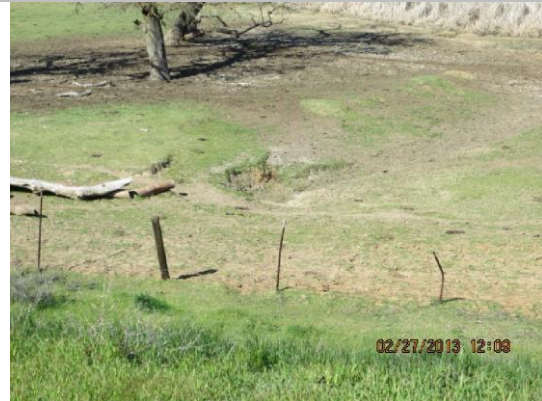
Photo 1 of 1 : UCIP_5966.jpg

LM Start	0.06	Rating **	M	Issue No.	1
LM End	0.06	Issue Type +	En	Location *	
Category	Supplemental			GPS Latitude/Longitude	
				Start	End
Item	DWR UCIP Field Study			38.985999 °	38.985999 °
				-121.509618 °	-121.509618 °
DWR ID	DWR_RD0784_06_s_2014_1				
Action/Comments					
Inspector Comments: FS_ID:29296					
EP_NO: N/A					
Repair Type:					
Crossing Status:					
UCIP Comments: Pipe partially blocked on LS and flap gate blocked on WS.					
FIELD_STRUCT_DESC: 18-inch CM drain pipe through the levee 19-feet below the crown. Gate valve on waterward side. Originally included in O+M Manual (1955). See Dwg. 2-4-106 Sheet 2.					
FS Date: 2/13/2014 9:27:53 AM

INlet at LS toe.

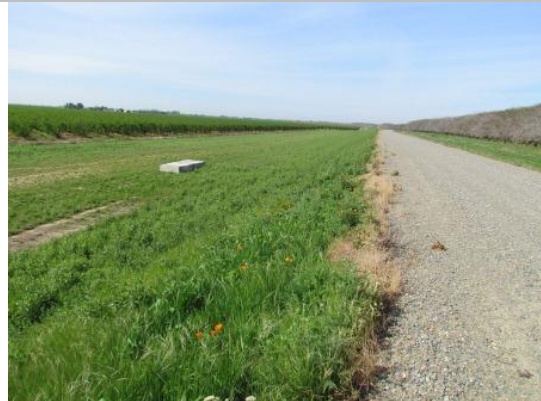
Photo 1 of 1 : mhoffman_s_20140410_422.jpg

This photo was taken from the crown facing west looking down the landward levee slope at vegetation growth requiring maintenance. Spring 2014.

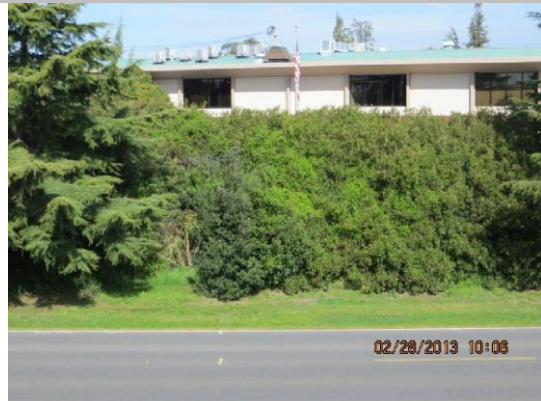
Photo 1 of 1 : UCIP_5935.jpg

LM Start	0.69	Rating **	M	Issue No.	1
LM End	0.69	Issue Type +	En	Location *	LS
Category	Supplemental			GPS Latitude/Longitude	
				Start	End
Item	DWR UCIP Field Study			39.138326 °	39.138326 °
				-121.540655 °	-121.540655 °
DWR ID	DWR_RD0784_07_s _ 2014_1				
Action/Comments					
Inspector Comments: FS_ID:29286					
EP_NO: 3446					
Repair Type:					
Crossing Status:					
UCIP Comments: USAA paint on roadway and flags along levee alignment. Needs proper markers.					
FIELD_STRUCT_DESC: 1-1/4-inch PG&E gas line through the levee, 2 feet below the crown. (Permit No. 3446)					
FS Date: 2/13/2014 9:22:37 AM

Alignment of pipe is approximately in-line with the flag pole on LS building.

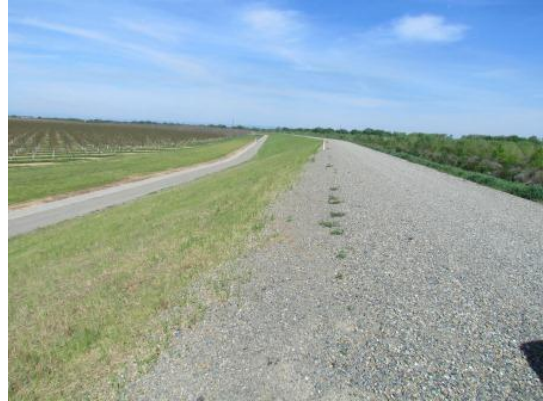
Photo 1 of 1 : mhoffman_s_20140410_426.jpg

This photo was taken from the crown facing east looking down the landward levee slope at acceptable vegetation maintenance. Spring 2014.

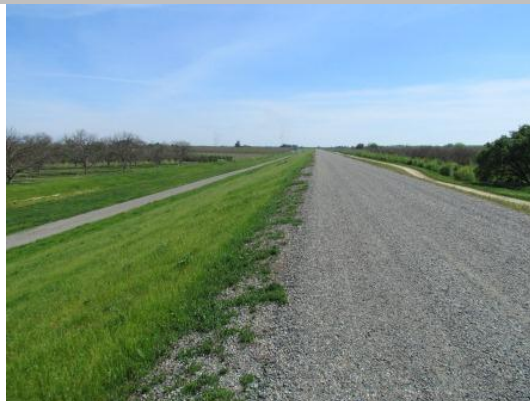
Photo 1 of 1 : mhoffman_s_20140410_424.jpg

This photo was taken from the crown facing south looking down the landward levee slope at acceptable vegetation maintenance. Spring 2014.
